RE: öWOODY GUTHRIEö
DOC#: 599274
HULL#: NONE
TYPE: 32øLOD HUDSON RIVER SLOOP

SURVEY SUMMARY

**~CAPT. G. W. FULL & ASSOCIATES – MARINE SURVEYORS~
“WOODY GUTHRIE” SURVEY SUMMARY PAGE 2**

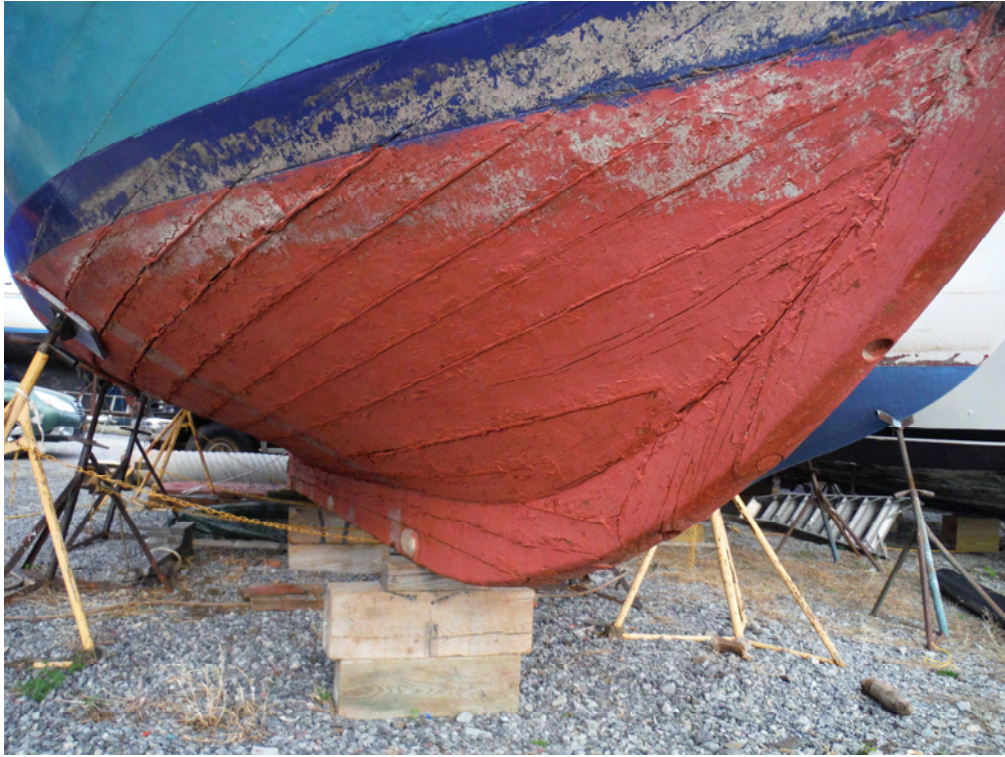
FORWARD VIEW OF BOTTOM 6 NOTE SEAMS

55. The bottom of the vessel has a reasonable heavy buildup of paint. This hampers the full inspection of the bottom. The bottom should be stripped of paint and then the bottom re-inspected.
56. At the same time as stripping the bottom, clean away the extra heavy buildup of seam compound.
57. The starboard plank #9 with the garboard as (1) is warped from where it starts below the water line and runs aft to the butt. Replace from the stem to the butt.
58. The same plank is sprung aft of the butt. Replace from the butt to the transom.
59. On the port side the mid butt plank #9 is sprung. Refasten this plank.
60. Going aft plank #9 has a split in the plank below the butt of plank #10. This plank should be replaced.
61. The rudder is loose on the rudder shaft. It appears that the hole in the gudgeon for the pintal is elongated. Fit a bushing.

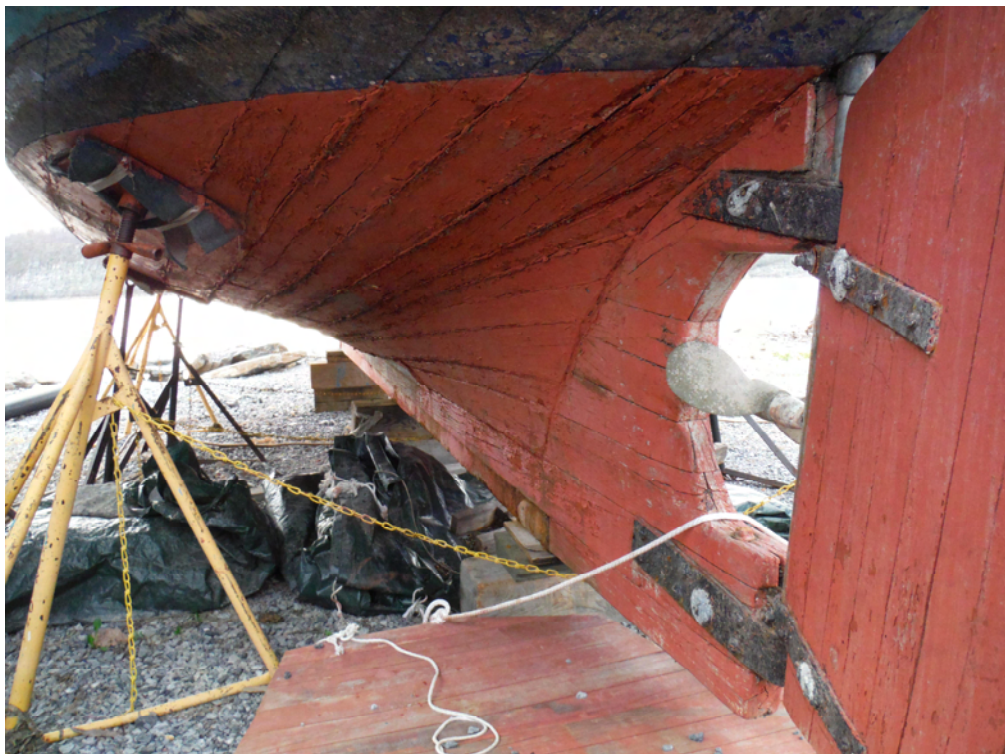
AFT VIEW OF BOTTOM 6 AGAIN NOTE SEAMS

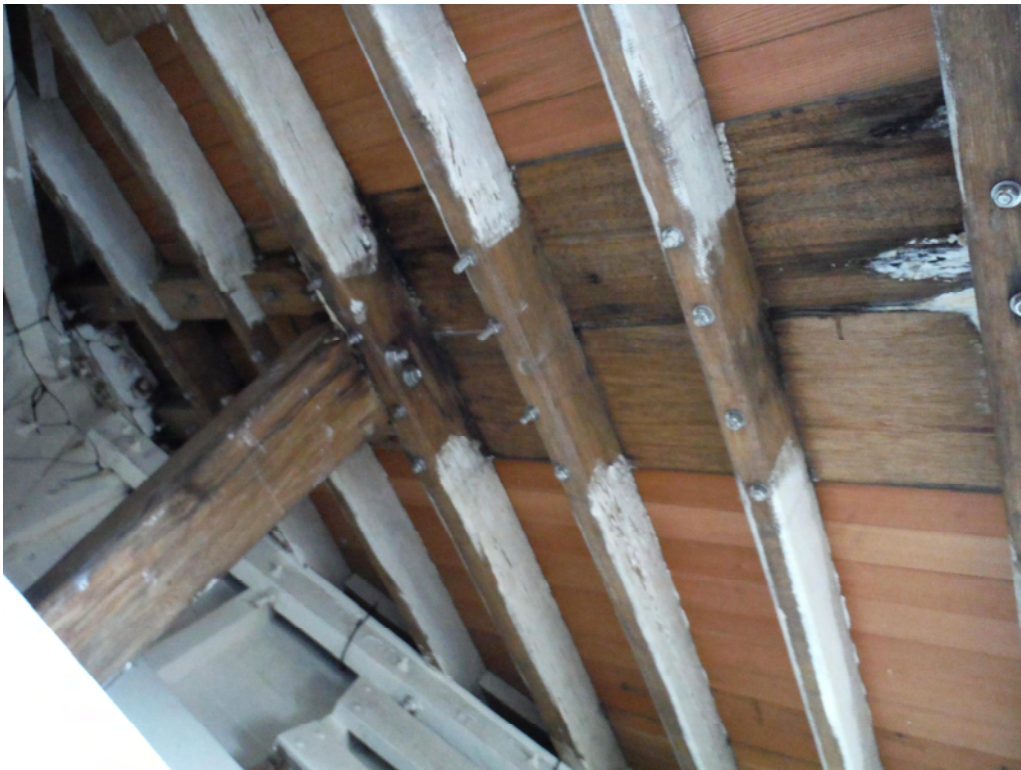
1. The underside of the king plank starting at the port side of the Sampson post and running forward is rotted, remove and replace the king plank.
2. The port Sampson post blocking is rotted at the Sampson post. This needs to be replaced.

VIEW OF UNDERSIDE OF KING PLANK 6 WHITE & BLACK AREA IS ROT

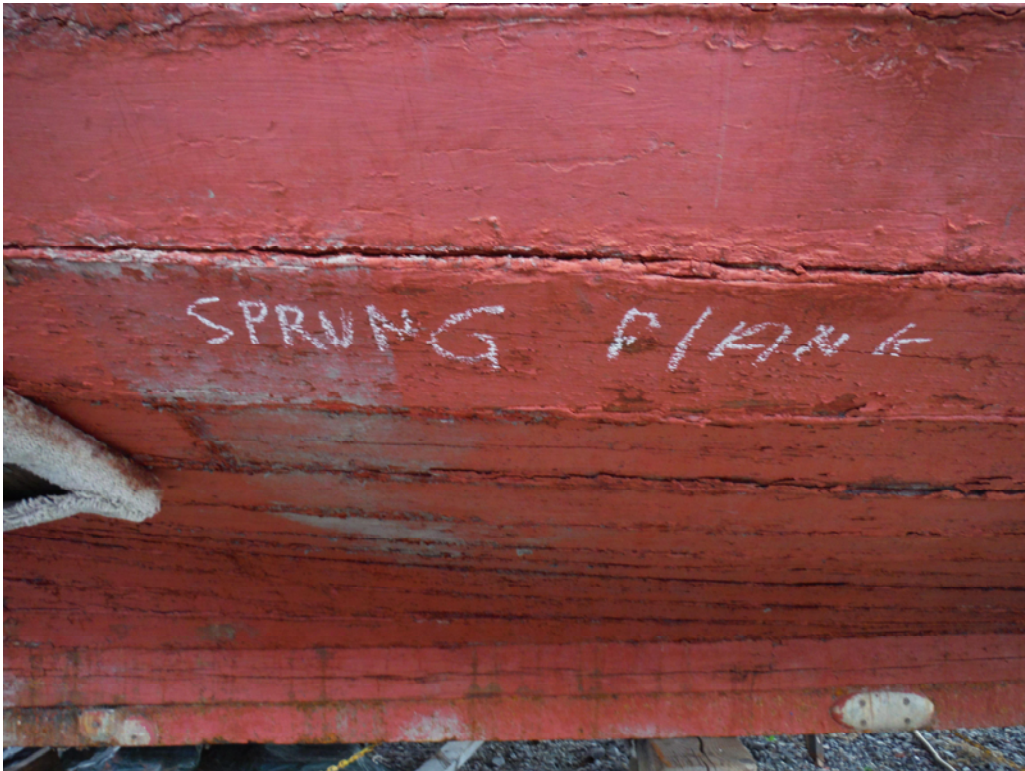
SPRUNG PLANK STARBOARD SIDE

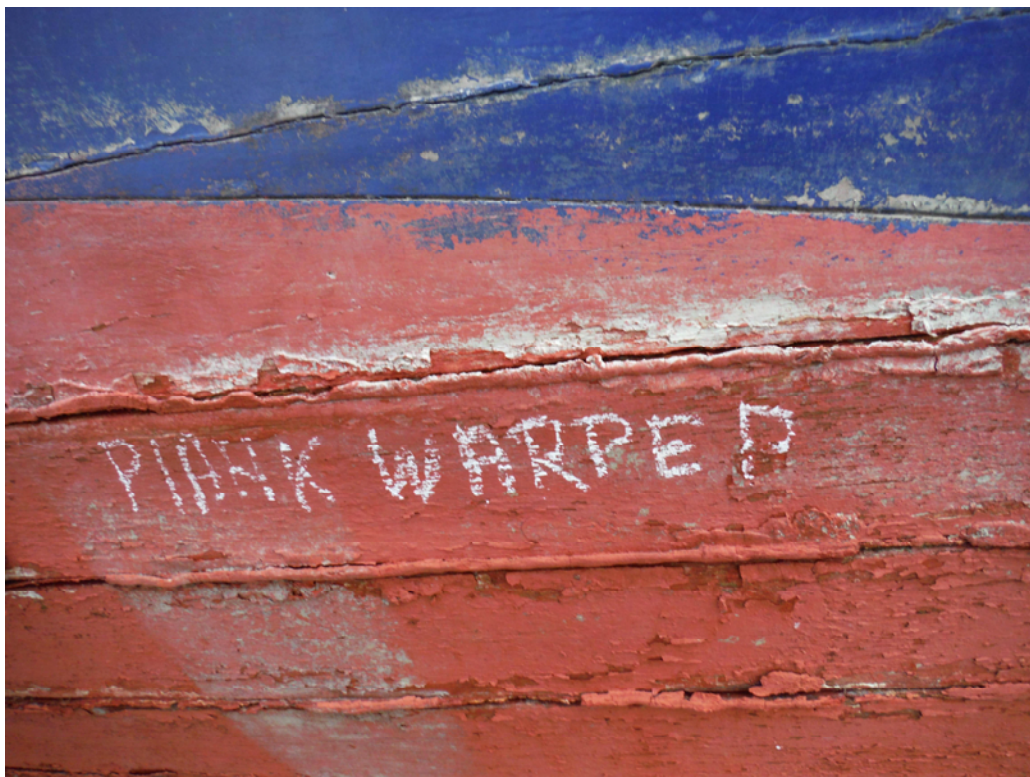
WARPPED PLANK STARBOARD SIDE 6 NOTE CONDITION OF SEAMS

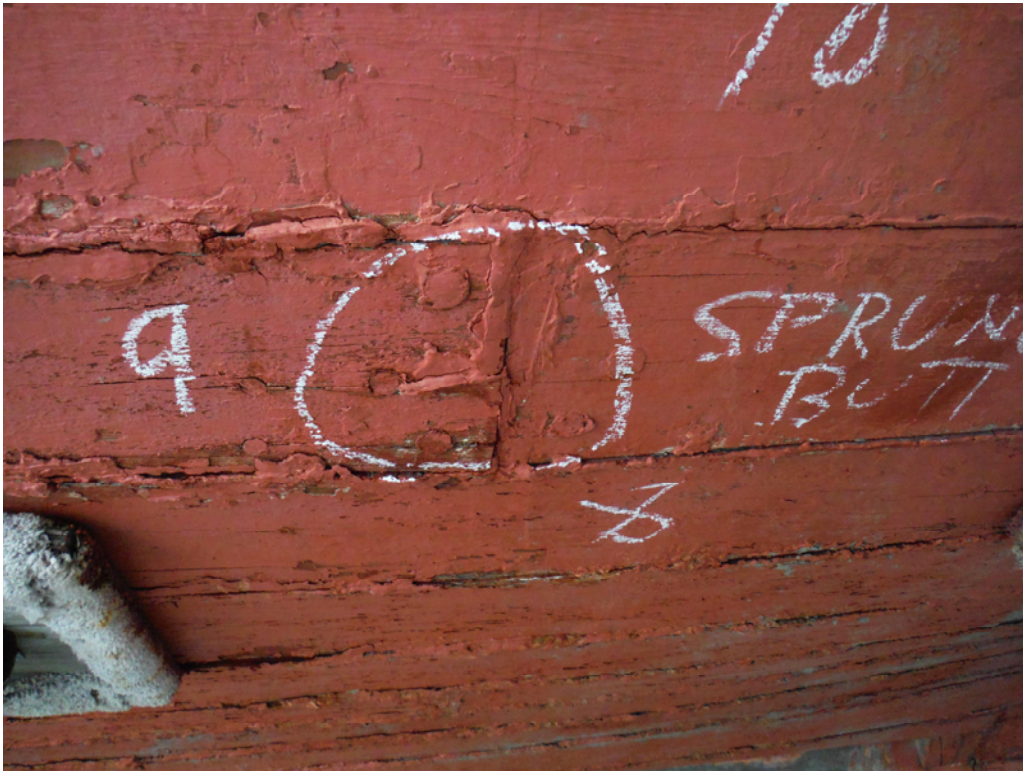
SPRUNG & POOR BUTT

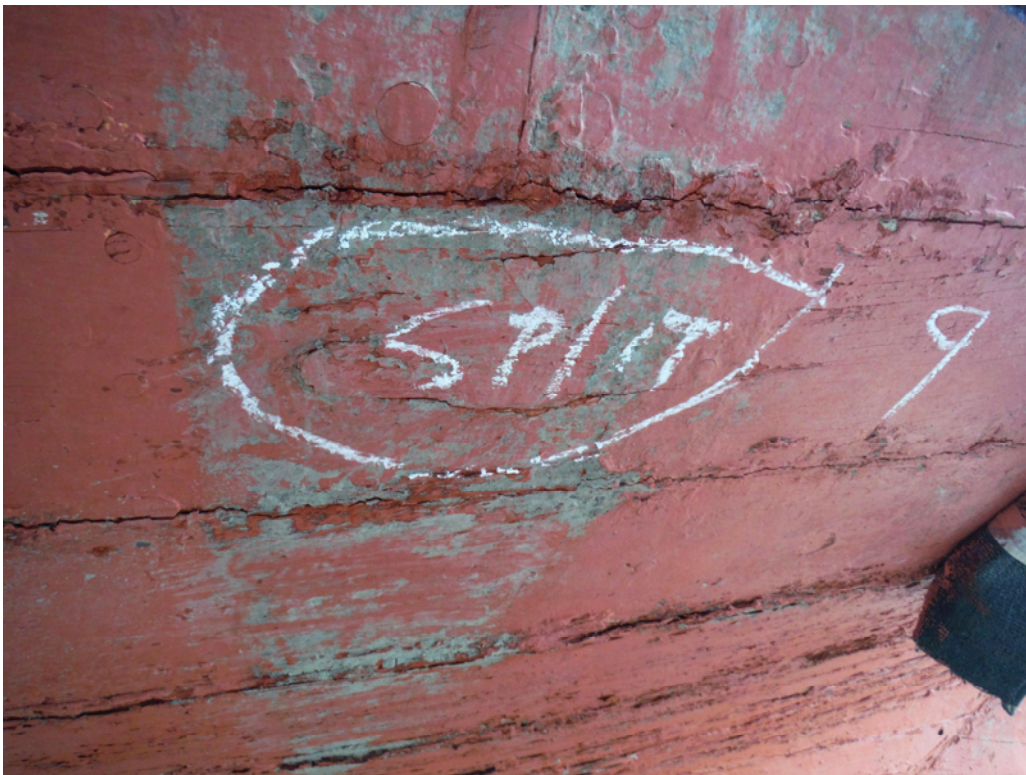
SPLIT PLANK
